Jetting and Camera Examination of Drains on the Village Green – 24/08/22

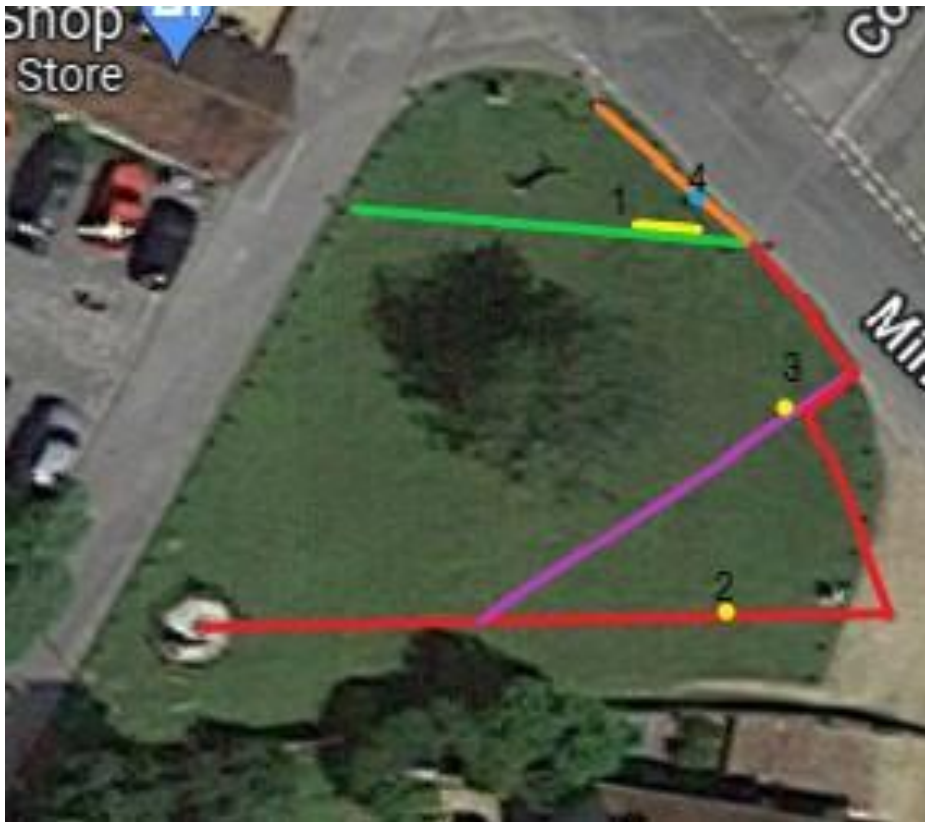
1) Diagram of drains jetted and examined

I'll go through the outcomes using the colour coding on the drains on diagram 1 above.

Fix the problems at yellow line 1 and yellow dot 2. This should allow water to flow freely along the green drain and the red drain and remove obstructions which could recreate the blockage. See if this makes things better this winter – hopefully if water can get away freely from the well this will help. If soggy patches re-appear think again. Sorting out the purple drain is difficult as we don't know where to dig.

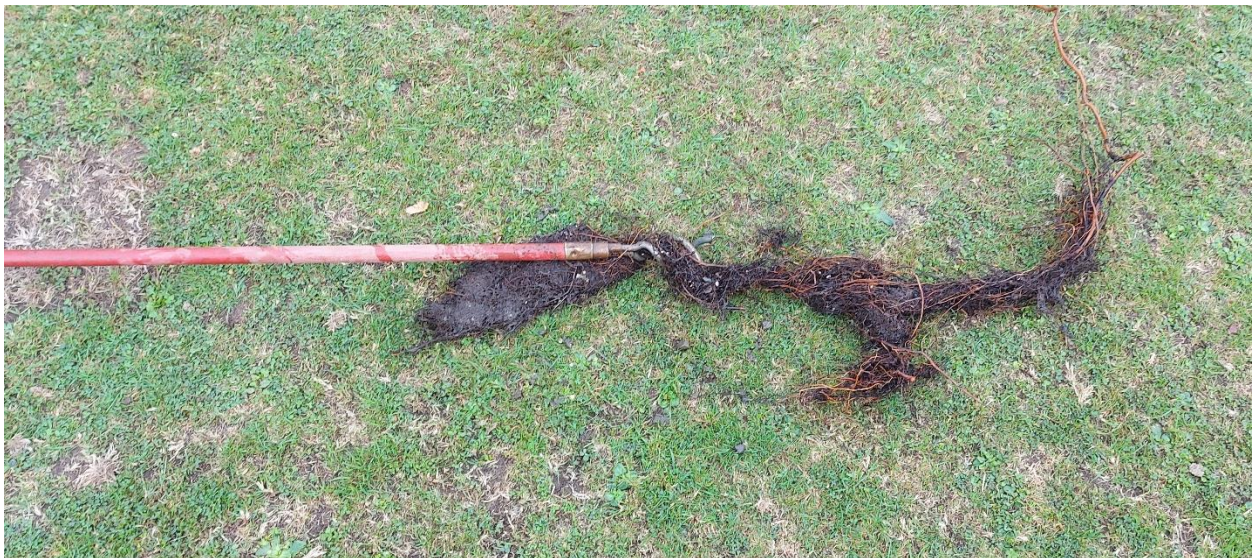
This was blocked by tree roots and gravel some 1.5 to 3.0 metres from the bottom storm drain (yellow line marked 1). They blew the gravel out and removed as many of the tree roots as possible but some are too big and wouldn't break. Water was running freely along this after jetting but with the tree roots still there it may well block up again. This is a modern plastic drain.

Some of the smaller roots.

- dig down to the drain along the affected area and cut and remove the tree roots from the outside. Look to stop these re-establishing – maybe with some concrete over the area where they were getting in.
- there is a catch pit under the manhole cover at the top of the drain run which is pretty full up – this needs to be cleared out. Pretty simple to do.

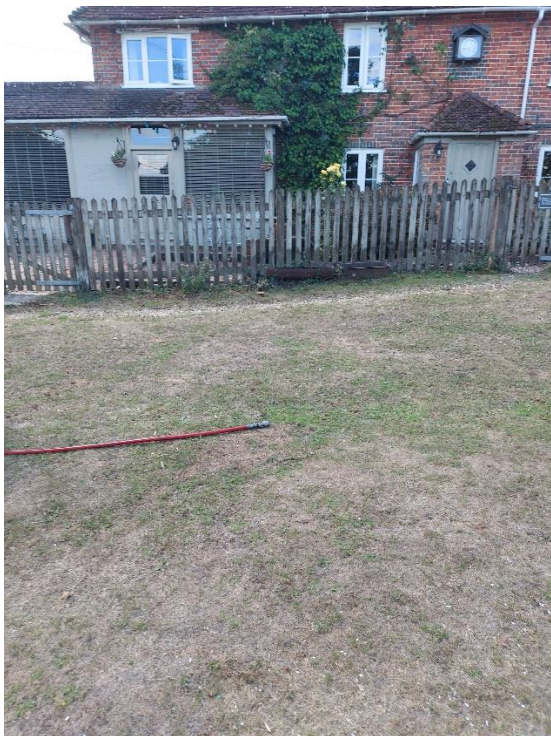
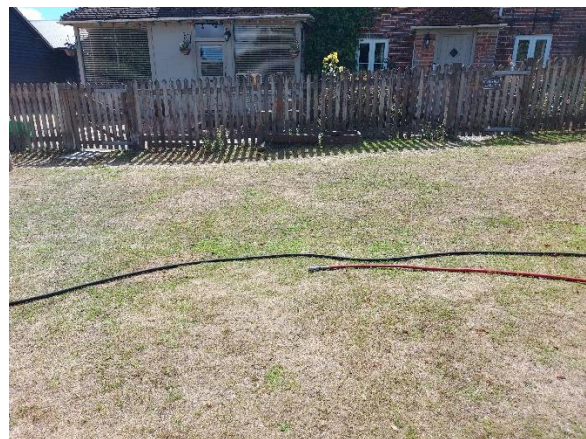
This was jetted from the well to the manhole cover from both ends. This is an old fashioned red clay pipe drain from the well to the manhole. There was an obstruction the jet couldn't get past from both directions at the yellow dot marked 2. The camera seemed to show some something fibrous at this point (possibly roots). The jetter blew down some bits of possible broken pipe but the drain was running OK. After this water was flowing freely along the entire length of the red drain – so right down to the roadside storm drain. The red drain flows into the bottom storm drain at the same point as the purple drain and it's very difficult to see where the junction is. Using the camera from the storm drain at the bottom seemed to show a break but

not a blockage where lengths of pipe were out of alignment at yellow dot 3. About 4 metres up from the storm drain. The run from the manhole cover in front of the Old Bakery down to the first storm drain was quite silted up but cleared pretty well with the water running down from the jetter. The manhole cover surround has broken free and is no longer attached to the bricks below – only the gravel keeps it in place.

Jetted from bottom and top to end of red bit of hose.

- dig down to the blockage point at yellow dot 2 to remedy the issue
- keep the run from the manhole down to the storm drain clear with regular rodding every few years.
- reset/replace the manhole cover to make it safer.

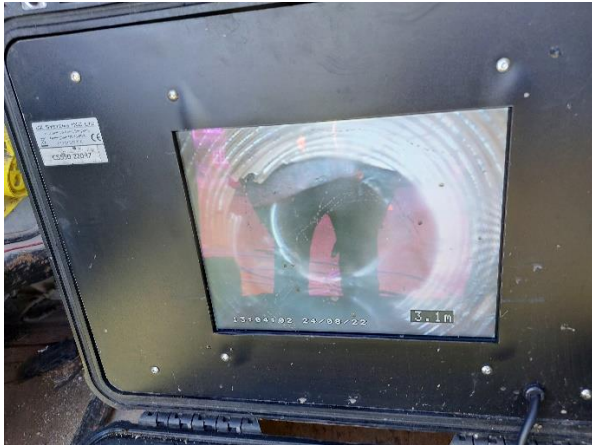
Misaligned pipes

- maybe leave this one alone – could dig out the misaligned pipes but as long as water flows along the red drain why bother?

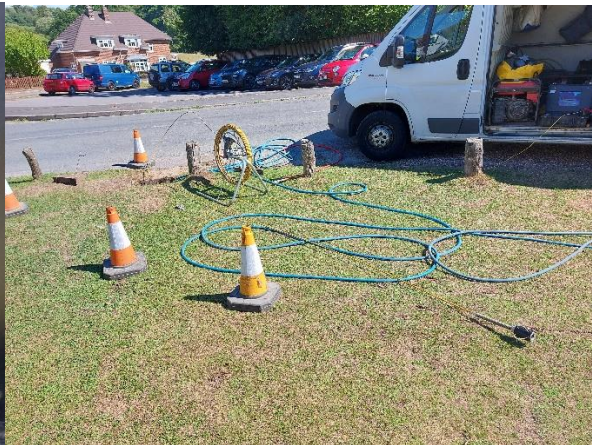
Camera where pipes are out of line

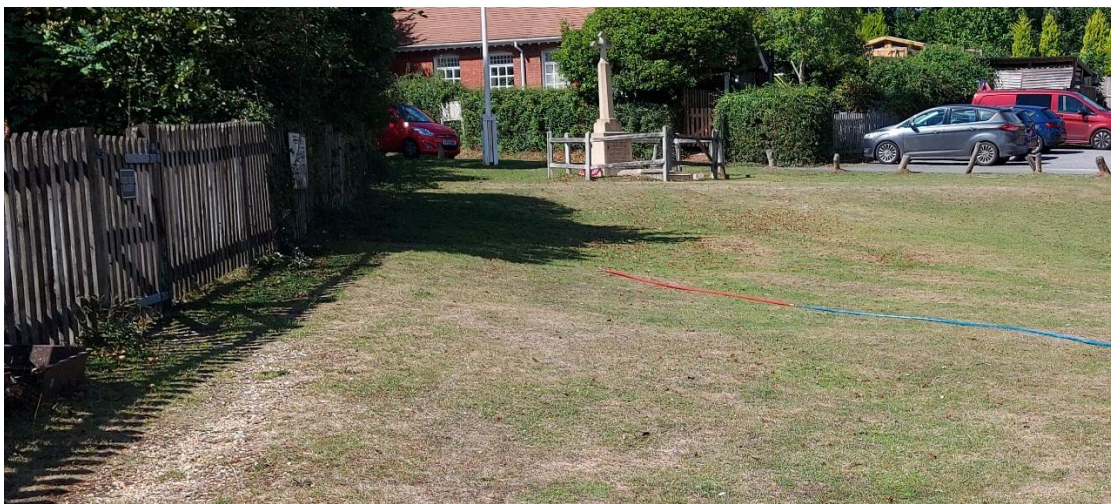
This was jetted and clear quite a long way until it hit a solid blockage. It's difficult to tell exactly which direction this drain runs in as we don't have an end point. It could form a junction with the red drain but that's very difficult to tell. When the red drain was jetted the water flowed along the red route and didn't use the purple route which implies that even there is a junction it is blocked. The camera showed the pipes out of alignment about 4m up from the storm drain at yellow dot 3 (see picture below). These look like quite substantial clay/concrete pipes. As stated above there must be a junction with the red drain before the storm drain as red and purple both come out of the same hole. Where we don't know.

Jetted clear to the end of the red hose – exact position of drain unknown.

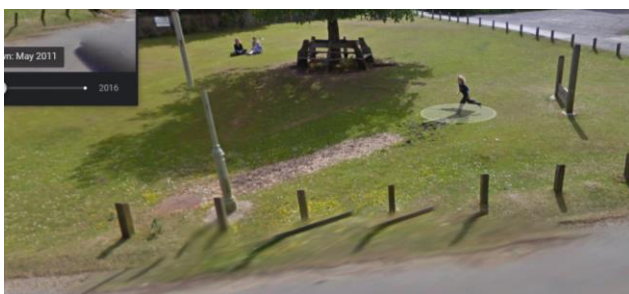
This is completely clear and free. The camera seemed to show a possible connection at blue dot 4 which could be from the French drain that HCC installed back in 2011. Can't be working properly as we still get the massive soggy patch. No suggested actions.

French drain done by HCC in 2011 from google streetview.
